Borehole Remediation Cambridge England.

Cirrus were contracted by their client to attempt yield improvement on a newly completed borehole in the Cambridge area.

## Airburst Field Data Record

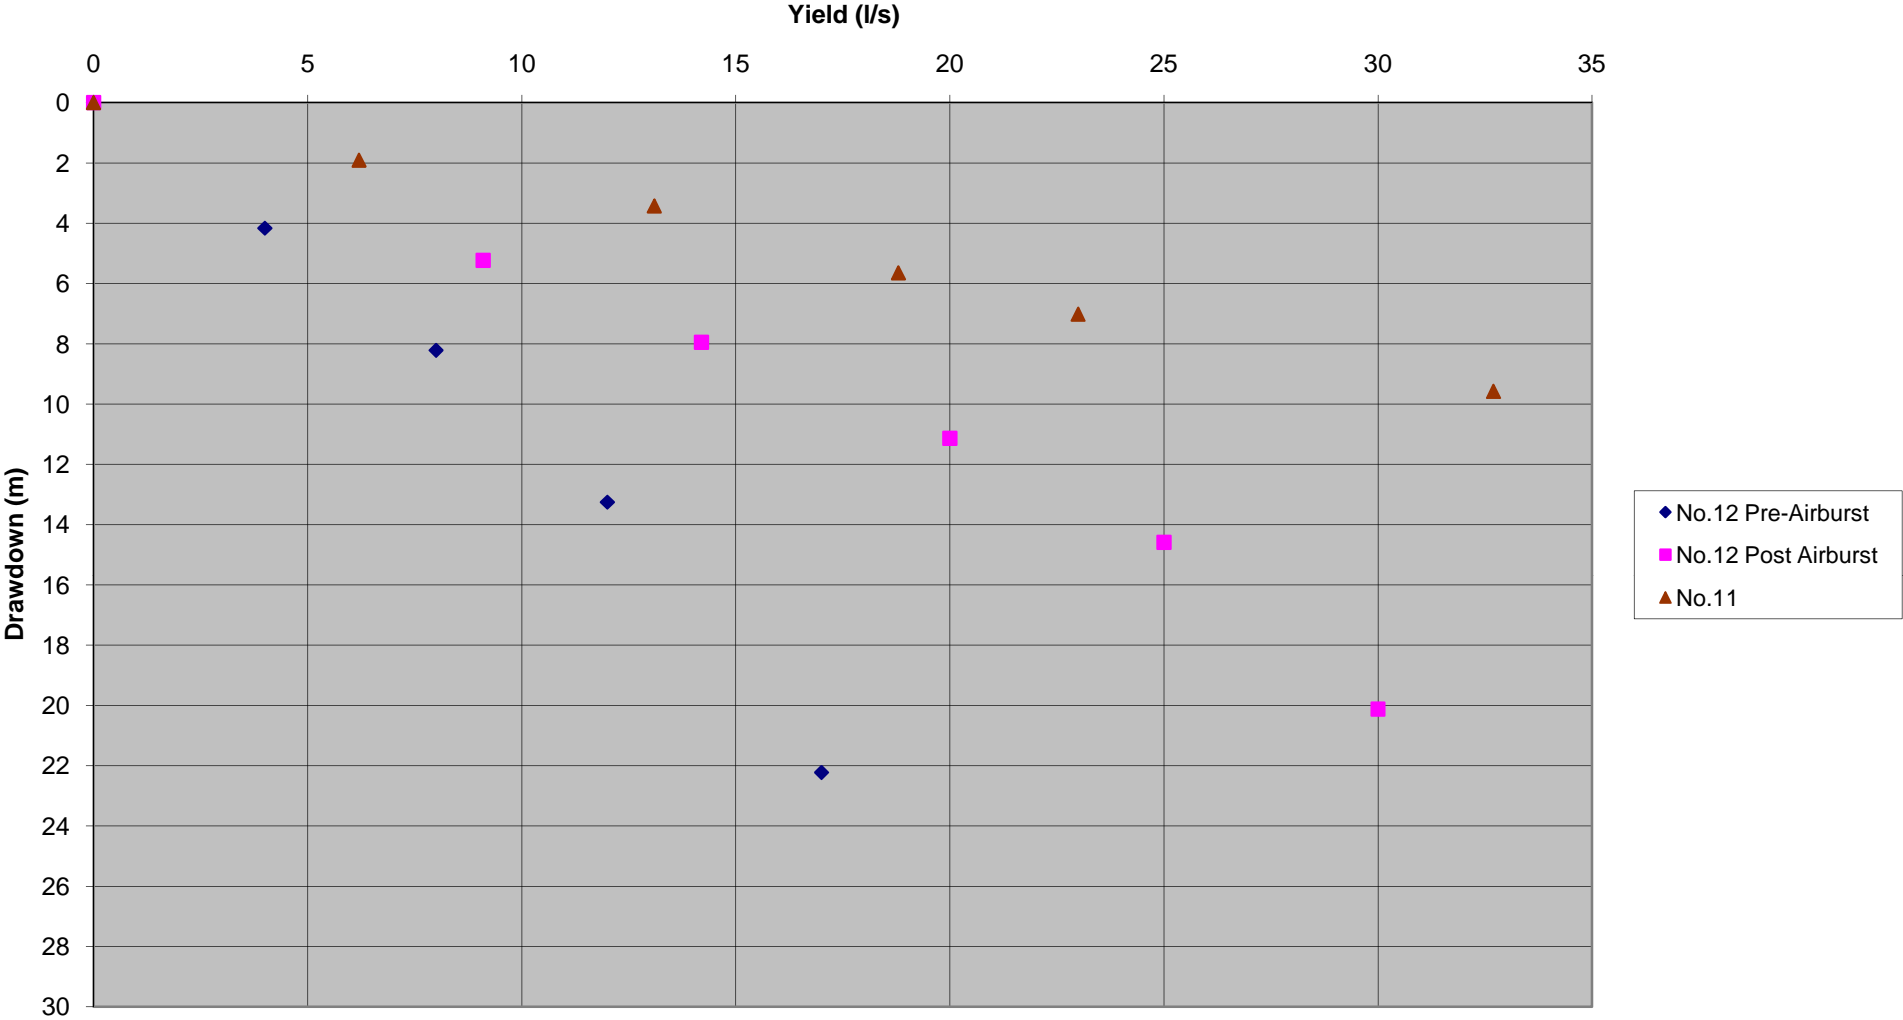
### Client Provided Yield-Drawdown Curves

Based on this and providing the existing hydrological conditions are favourable we should see a considerable improvement in borehole performance.
